John Oyler
Zinc Corporation of America

Mr. Oyler spoke on the practice and principles of restoring damaged landscapes. Mr. Oyler has been a plant materials specialist on a number of damaged sites, including the Palmerton, PA Zinc Superfund Site and the remediation of the area around Mt. St. Helens. He has also developed plants and technologies to solve many environmental problems.

The following is a transcription of Mr. Oyler's keynote address.

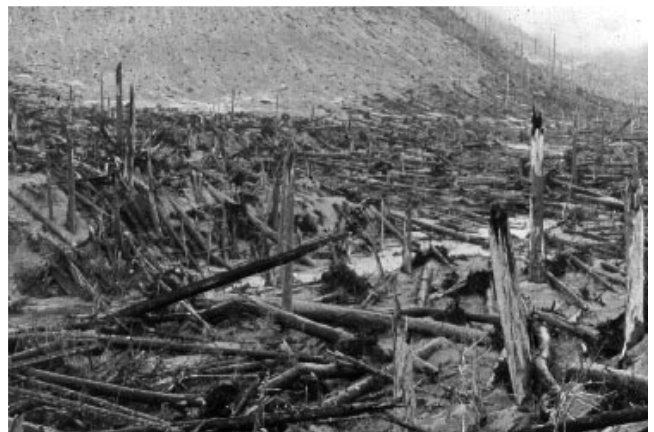
The Blue Mountain site was contaminated by heavy metals.

In 1982 EPA came in and proposed listing it on the NPL (National Priorities or Superfund List) and in 1983, it was finally listed. That's when I got involved. While the sulfur dioxide was in the air, fumigating the forest, you had particulates of lead, zinc, and cadmium dropping back out of the sky (that had come out of the stacks). Here's what you're left with. We had—the earliest reports we could find were letters to the editor, or notes, as far back as 1922 where amateur naturalists were talking about the understory on Blue Mountain. It didn't look like it had in the past, and the blueberries weren't as good as they had been, etcetera. We found aerial photos from the 1930s to the present and you can see holes in the canopy of the forest appearing in the 1930s. They are getting larger by the 1950s. By the late '60s and early 1970s, the ecosystem had just been stretched like a rubber band and couldn't

What in fact happened, the existing trees were rooted a couple feet deep in that soil. All the metals that were hitting that soil got bound on soil particles and didn't go much below six inches deep. The sulfur dioxide was working on them, but as the sulfur dioxide finally took out the old growth forests, young trees couldn't come in and the whole thing just collapsed. The high zinc levels in the soil took out the soil microbes, bacteria in particular, and so there's no decomposition. There are no nutrients cycling. There's no food. Zinc, of course, is the active ingredient in a lot of your burn creams because it does kill bacteria so well, as you can see here. So what do you do?

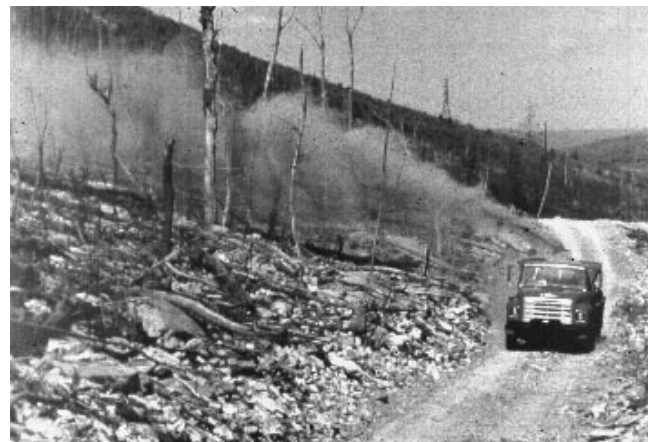
A truck designed to blow flyash and sludge up to 100 feet up the slope.

The truck that you are looking at is the real key to this. It's similar to a salt truck or a cinder truck, but instead of having spinners that throw material out to the side, it has a fan that literally blows the material out. This is critical because you have to be able to apply solid material on slopes like this. We found that we can apply with consistency 100 feet uphill or downhill from the terrace routes. We brought in fly ash and sludge, mixed them up on site transported them up the mountain. Here we are blowing on the sludge and fly ash.

It's about 54 percent, 55 percent solids after it's mixed. We can lay it down. We're putting on about 200 wet tons per acre or product tons per acre. That's about two inches deep on completion. It would lay down five foot, 30 foot, 70 foot, 90 foot—two inches deep all the way back. It was like a lawn sprinkler.

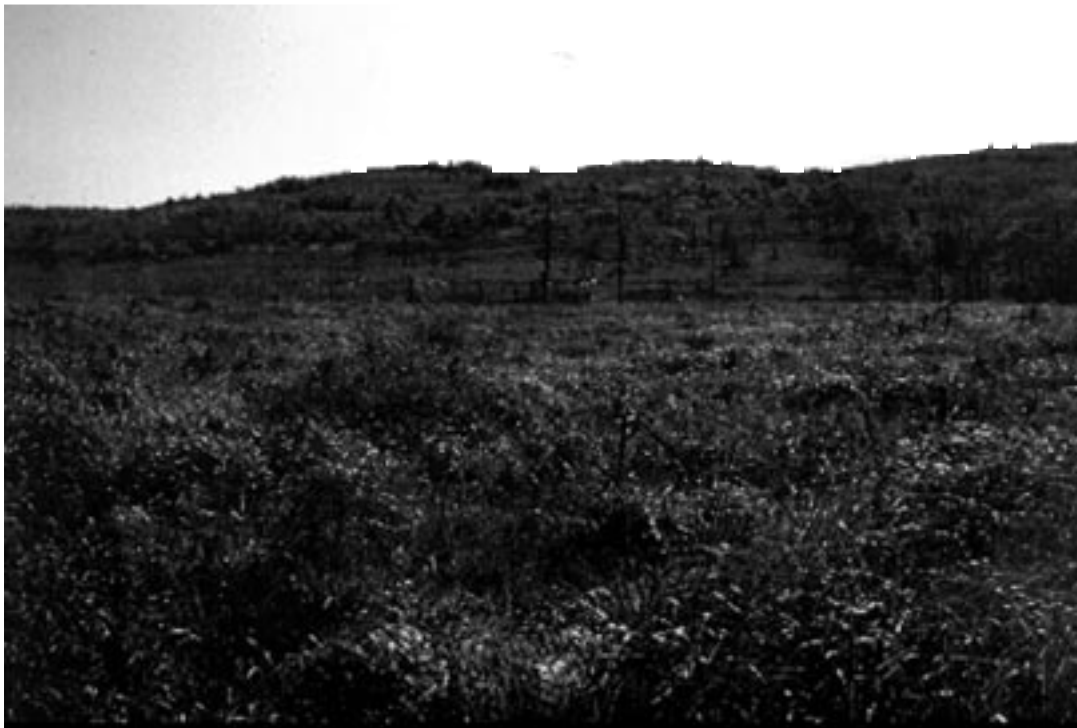
The Blue Mountain project began in 1988. This photo shows an area called Stoney Ridge in May of 1996.

Here’s a shot from across the valley, on an area called Stoney Ridge, actually, a terminal moraine from the last glacier, looking at the north face of Blue Mountain. This is May of 1996. You can see that we have greened it up. We are real pleased

with it. Because of the regulatory considerations on a Superfund site, we had to plant more grass than I like and now we’re paying the price for that. We don’t have as many trees as I would like yet, but I suspect that as the grass competition decreases in the future that more trees will be coming out. We closed out our terraced roads on the way out. We just treated them so they’re all vegetated again, too. We still have the access roads open, though.
